Thermal Image Moisture Report

NZ Moisture Testing
PO Box 97528, S.A.M.C
P 0800 NZ Moisture
M 021 753 411
E info@nzmoisturetesting.co.nz
www.nzmoisturetesting.co.nz

Report Date 1/03/2011

House description - Four bedroom, two storey dwelling. Plaster construction with a tile roof and aluminium joinery. House inspected at 9am in clear sunny conditions. Contact person: xxx xxx

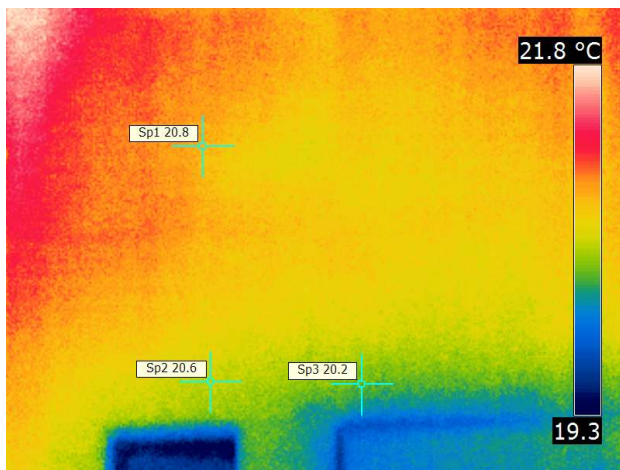
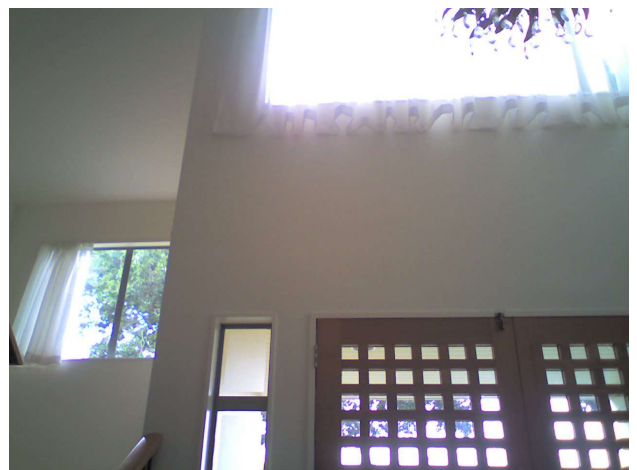
Entryway - No thermal variations detected in this area. All moisture readings around doorway below 40 digits at time of inspection.

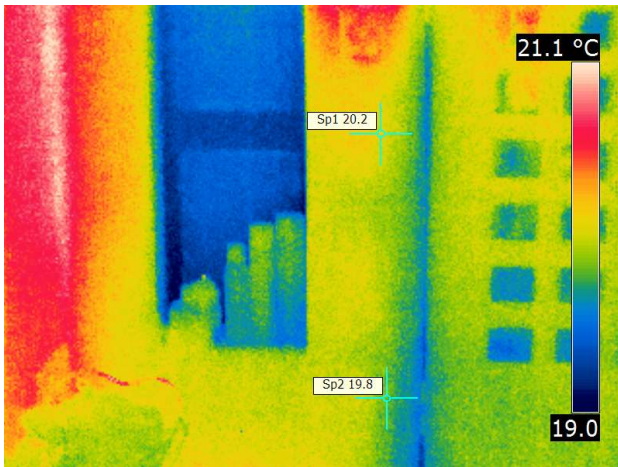
Entryway - Low moisture readings taken around doorway near floor. All moisture readings below 40 digits at time of inspection.

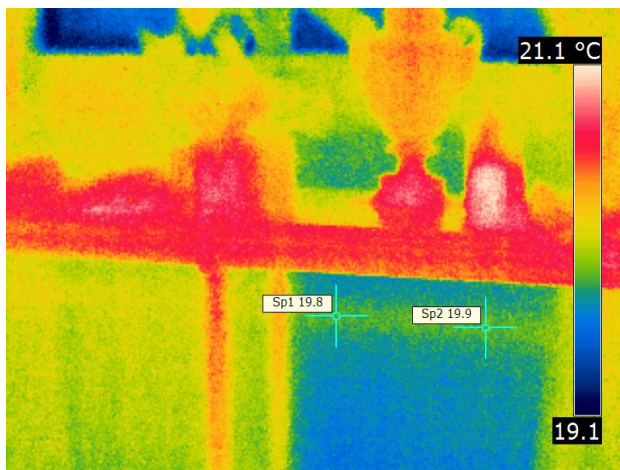
Entryway - Low moisture readings below 40 digits detected in this area below window. Small cracks noted in wall in this area and also areas above doorway.

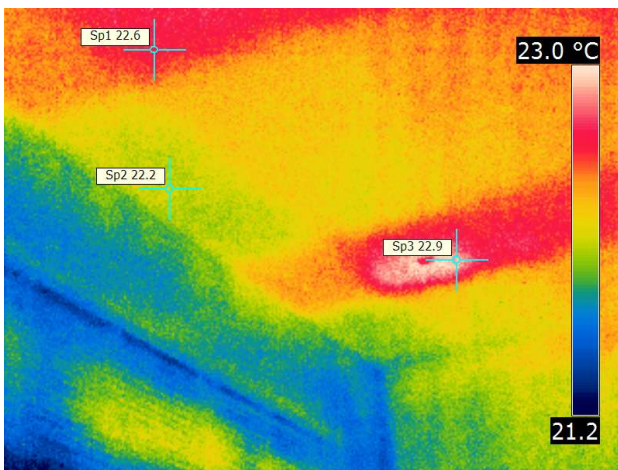
Kitchen - Walls in kitchen tiled to ceiling, moisture readings unable to be taken from tiled areas. Areas of thermal variation in ceiling may be due to missing or damaged insulation. Moisture readings below 40 digits in this area at time of inspection.

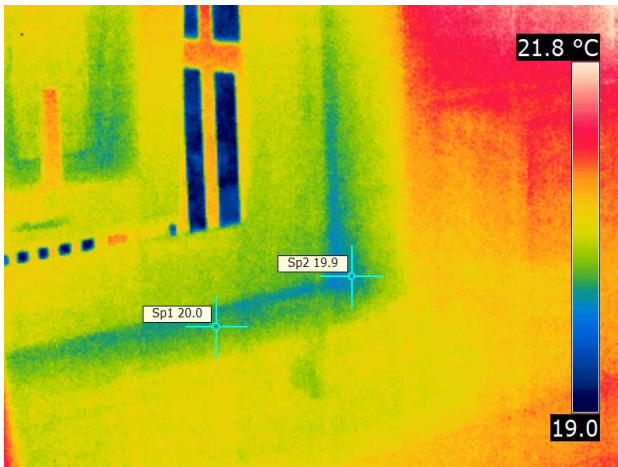
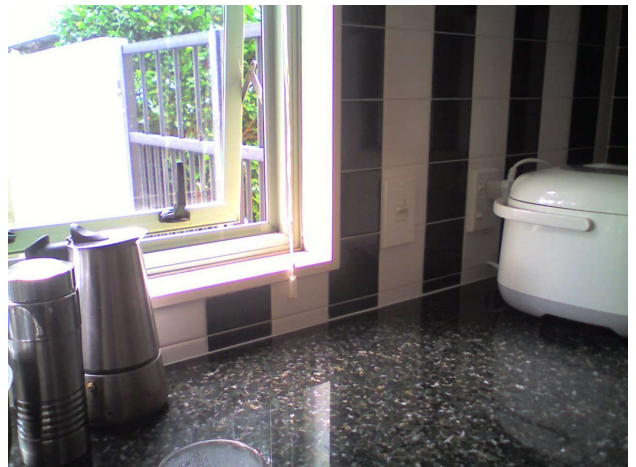
Kitchen - Areas of previous water damage detected in corner of window frame. Mould located in this area. Moisture readings above 40 digits at time of inspection.

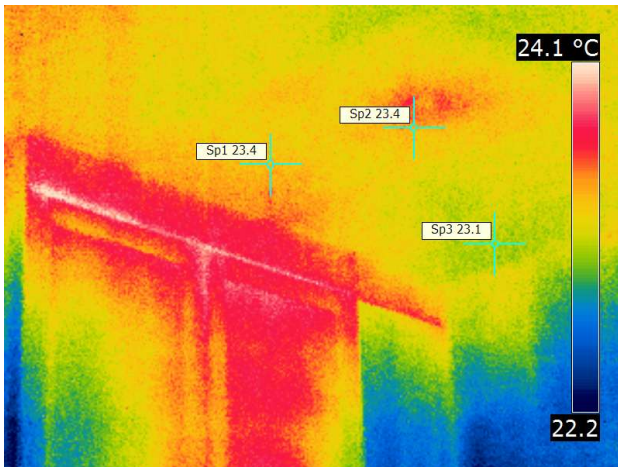
Kitchen - Areas of minor thermal variation in ceiling may be due to missing or damaged insulation. All moisture readings below 40 digits in this area of kitchen at time of inspection.

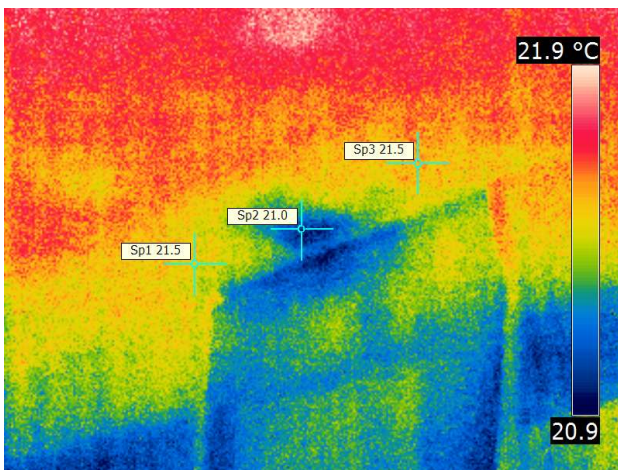
Living room 1 - Minor thermal variation detected in areas of ceiling in this living room. No elevated moisture readings were detected in this area at time of inspection. All moisture readings below 40 digits in this area.

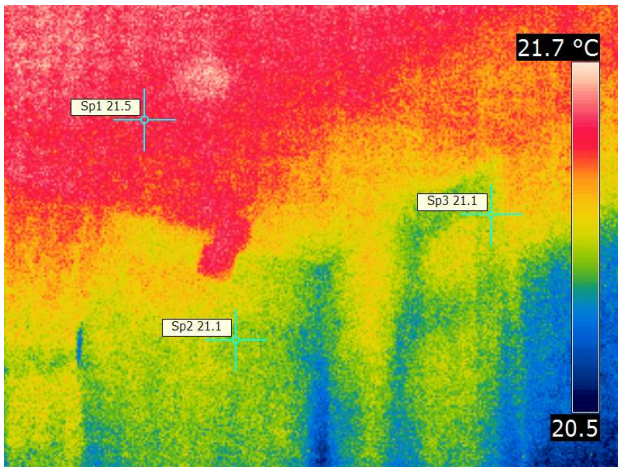
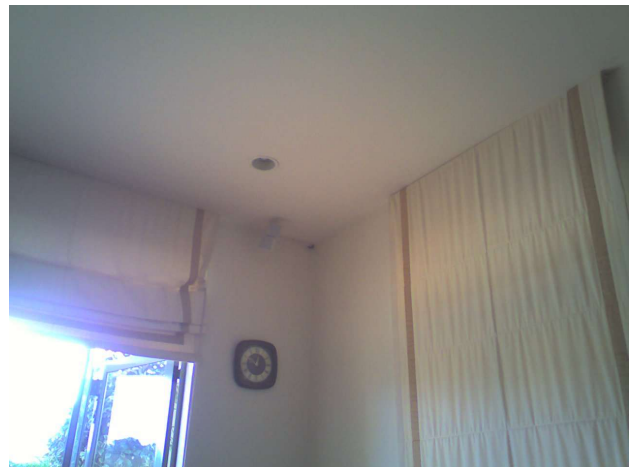
Living room 1 - Small cracks noted in wall from top corners of window frames to ceiling above most windows. Moisture readings slightly above 40 digits in these areas on lintels consistent throughout house.

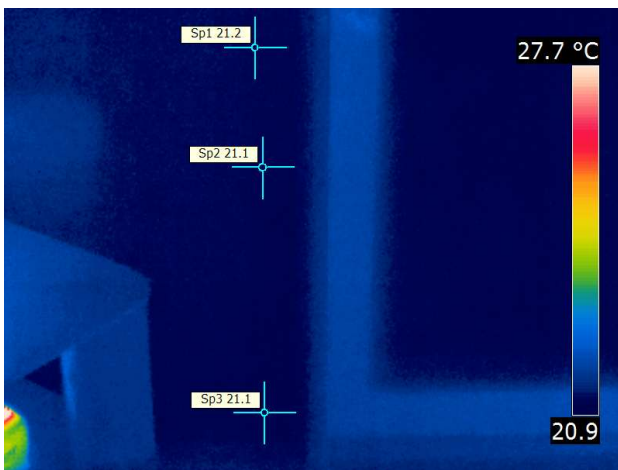
Living room 1 - Moisture readings above 40 digits detected in areas near floor to side of doorway. No thermal variation detected in this area at time of inspection.

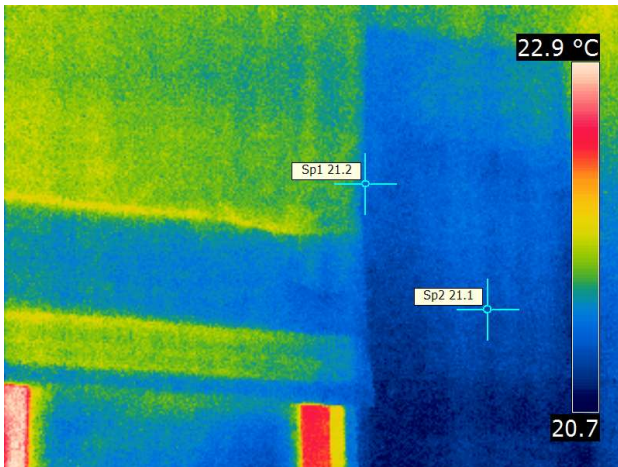
Dining room - Small cracks noted in wall from top corners of window frames to ceiling above most windows. Moisture readings above 40 digits in these areas on lintels consistent throughout house. No thermal variance detected in this area.

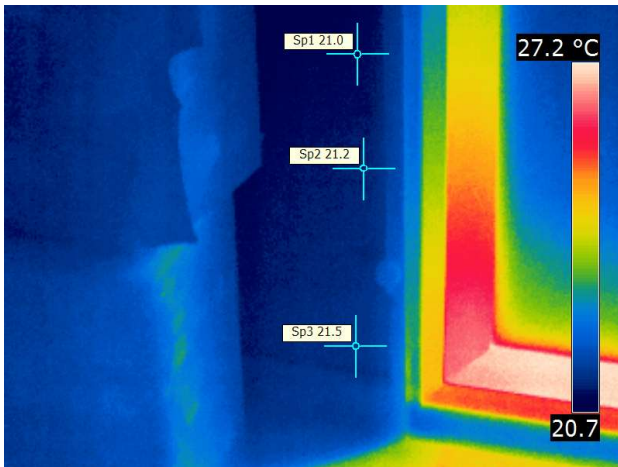
Dining room - Moisture readings above 40 digits detected in areas near floor to side of doorway. No thermal variation detected in this area at time of inspection.

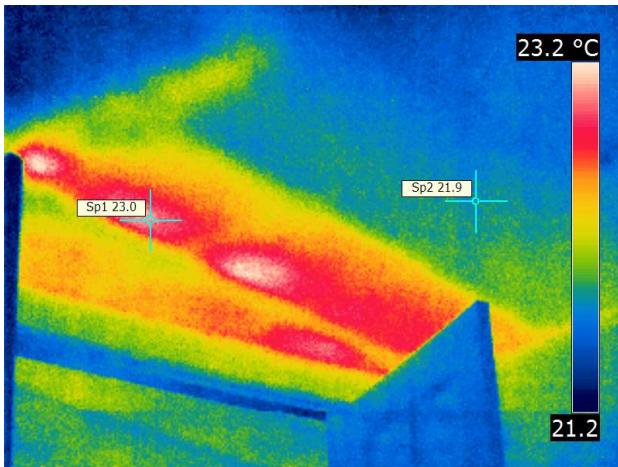
Living room 2 - Areas of minor thermal variation in ceiling may be due to missing or damaged insulation. All moisture readings below 40 digits in this area of living room at time of inspection.

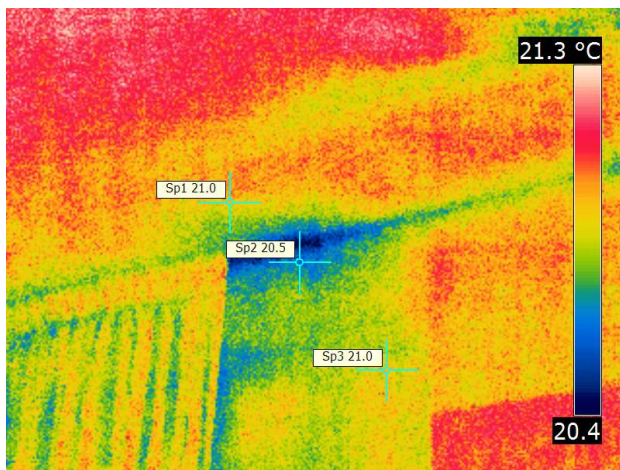
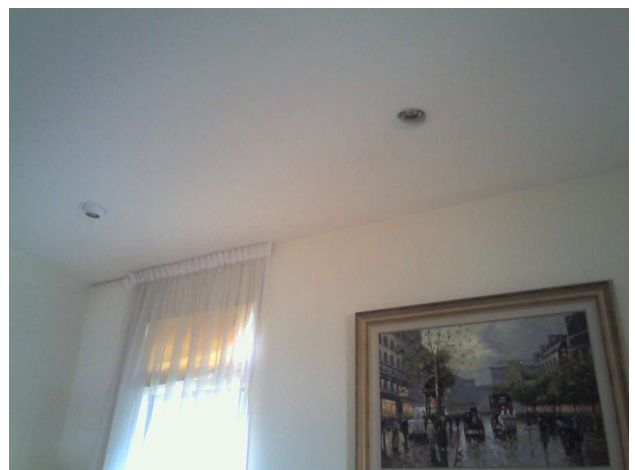
Living room 2 - Minor thermal variation detected in area near corner of ceiling above window in this room. Moisture readings slightly higher in this area, still below 40 digits at time of inspection.

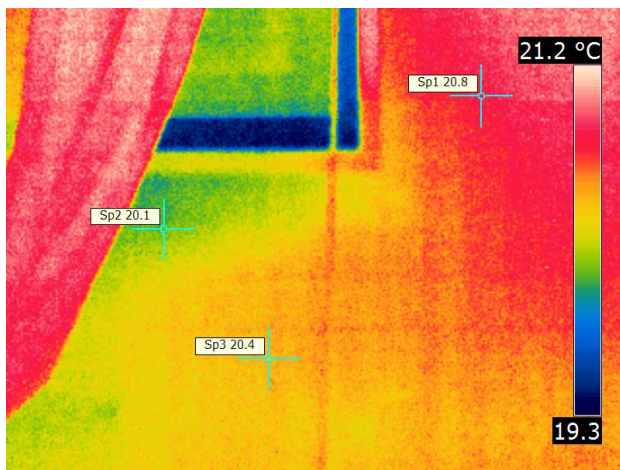
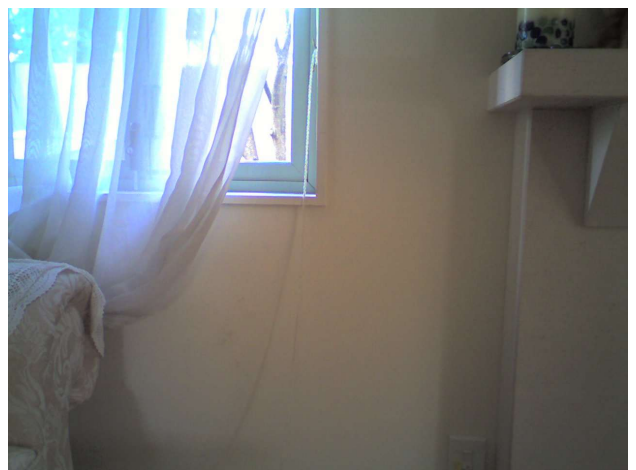
Living room 2 - Moisture readings above 40 digits detected in this area of living room below window frame. Patches of mould present on wall below window. Minor thermal variations detected in this area at time of inspection.

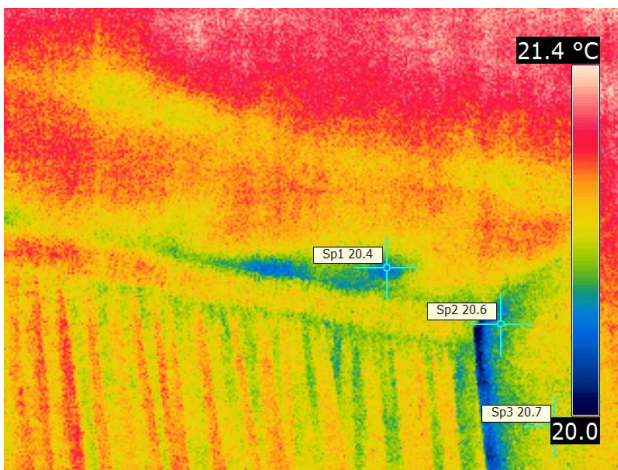
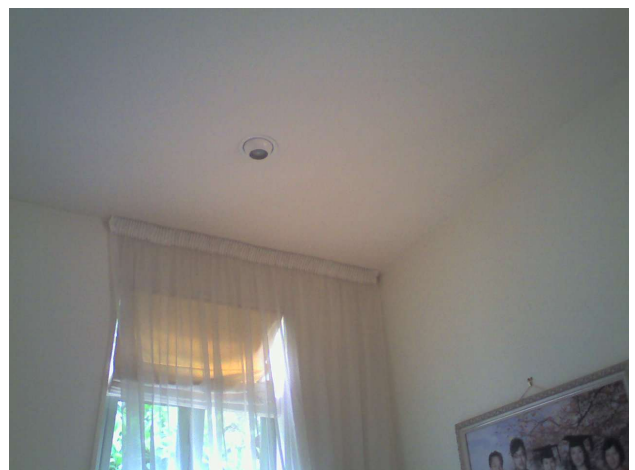
Living room 2 - Minor thermal variations detected in areas near corner of ceiling above window in this room. Moisture readings slightly higher in this area, below 40 digits at time of inspection.

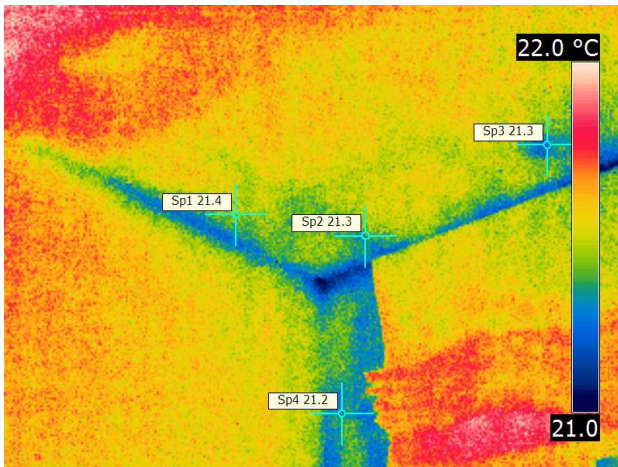
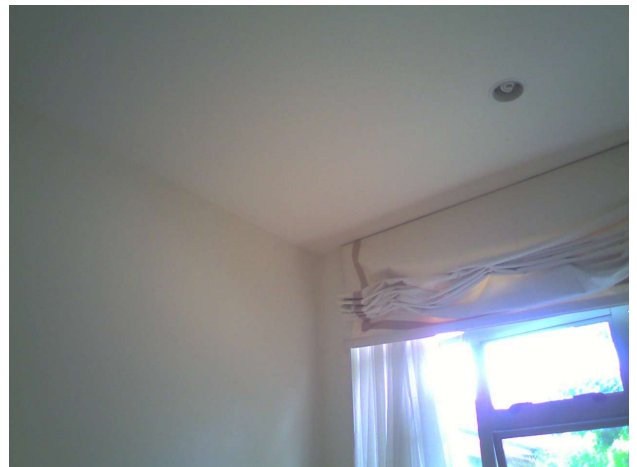
Office - Minor thermal variation detected in areas of ceiling in this room. No elevated moisture readings were detected in this area at time of inspection.

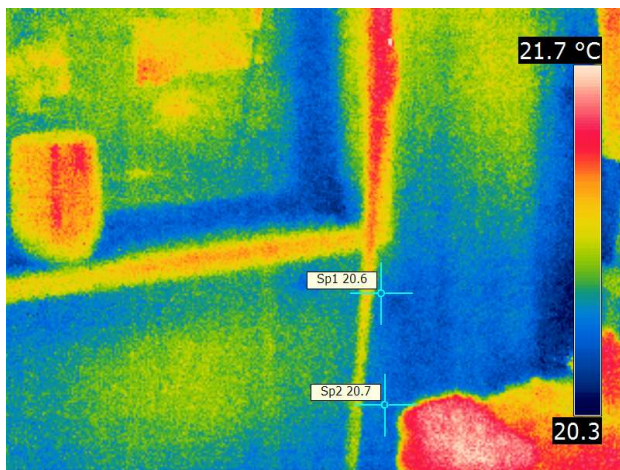
Office - Moisture readings above 40 digits detected below right hand corner of this window in office. Minor crack located in this area. Moisture readings below 40 digits in this area at time of inspection.

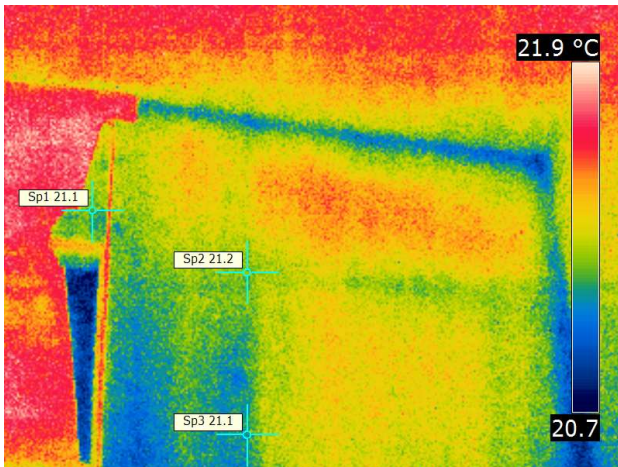
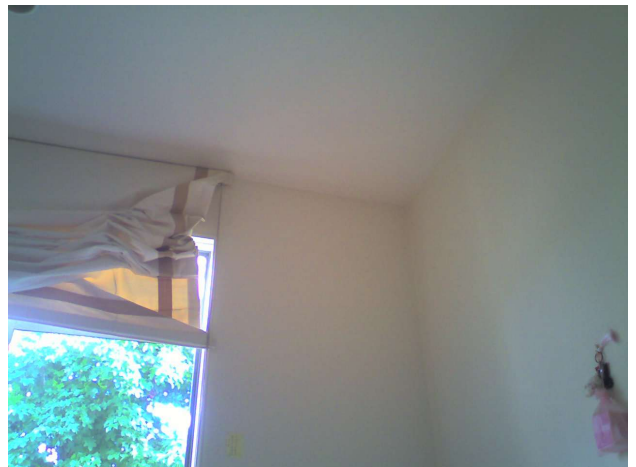
Office - Small cracks noted in wall from top corners of window frame to ceiling above window. Moisture readings slightly above 40 digits in these areas on lintels consistent throughout house. Minor thermal variation detected in areas of this wall.

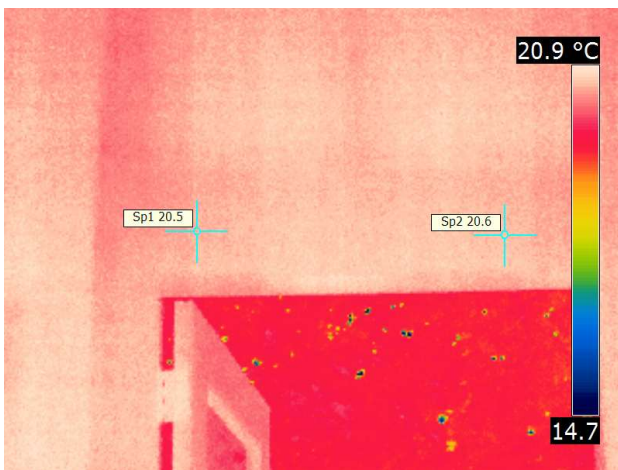
Laundry - Highest moisture readings in this laundry attained from areas of wall above this doorway. All moisture readings in this area below 40 digits at time of inspection. No thermal variation present in this area.

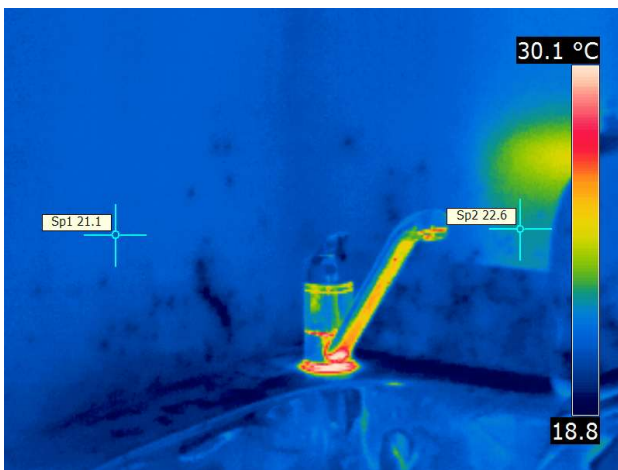
Laundry - Moisture readings on wall around sink area below 40 digits. Laundry in use at time of inspection.

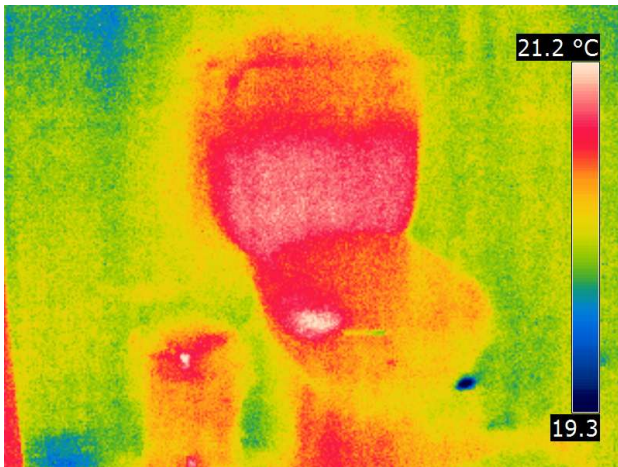
Bathroom (downstairs) - Walls in bathroom tiled from floor to ceiling, moisture readings unable to be taken from tiled areas. Areas of ceiling and window frames indicated low moisture readings below 40 digits at time of inspection.

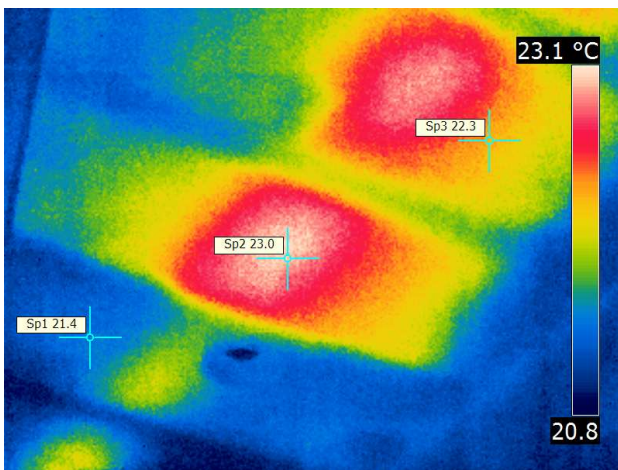
Bathroom - All moisture reading taken in this area below 40 digits at time of inspection. Thermal variances in areas of ceiling may be due to missing insulation. No elevated moisture readings in this bathroom.

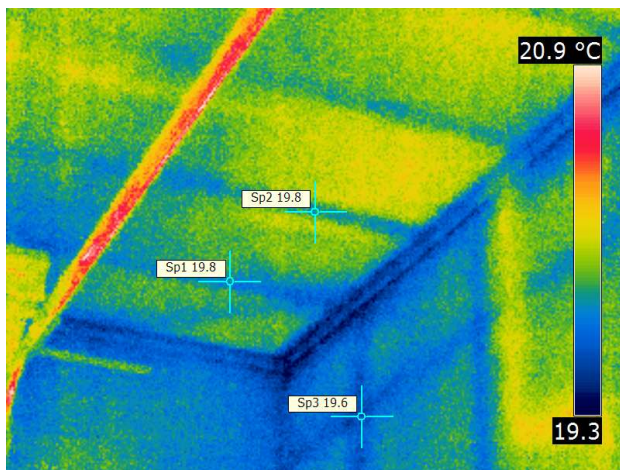
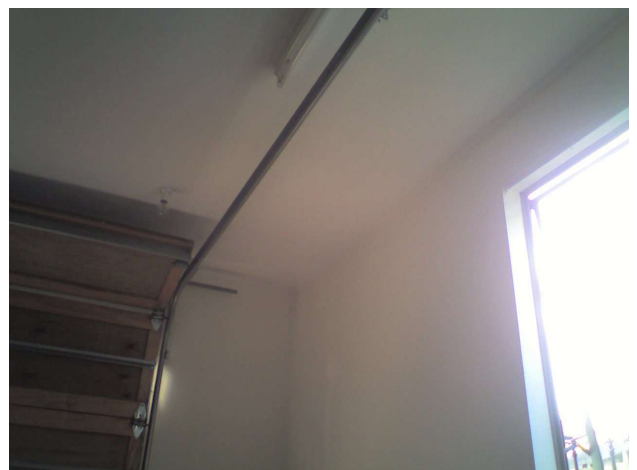
Garage - Even temperature distribution shown in this area with no areas of thermal variations. All moisture readings below 40 digits in this area at time of inspection.

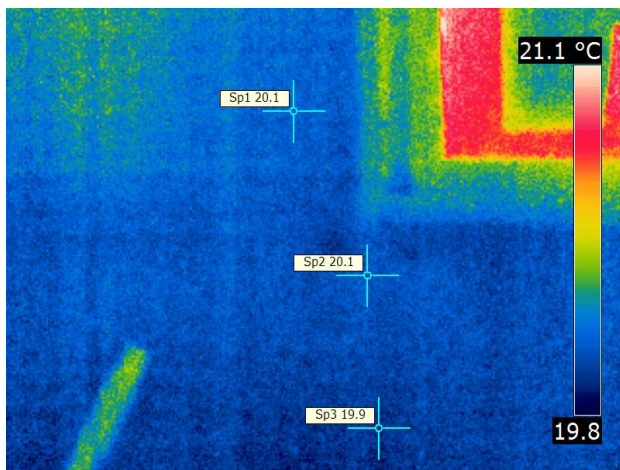
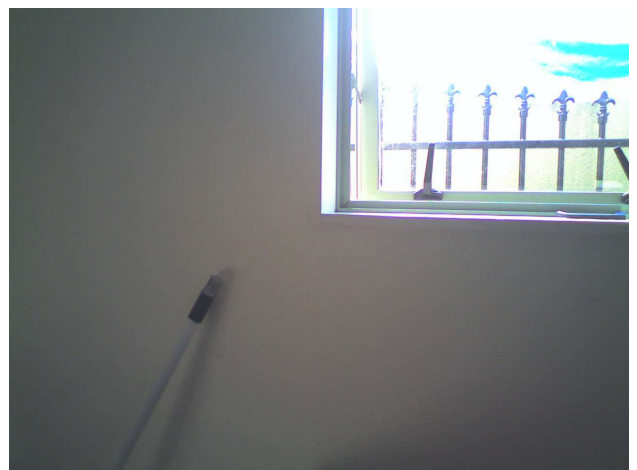
Garage - Slightly elevated moisture readings detected below left hand corner of this window. Small cracks in wall and bubbles below paint noted in this area. No thermal variation detected at time of inspection.

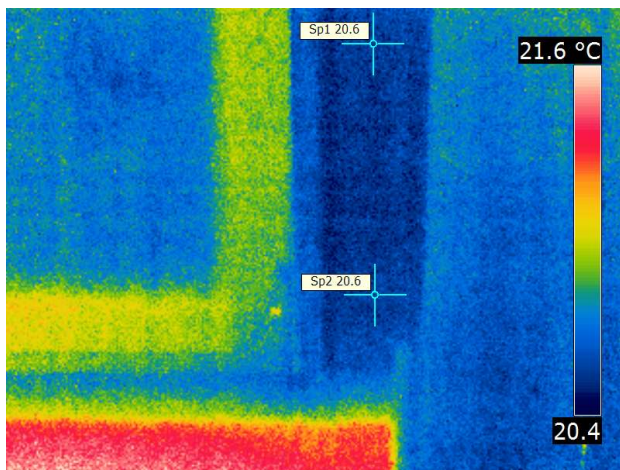
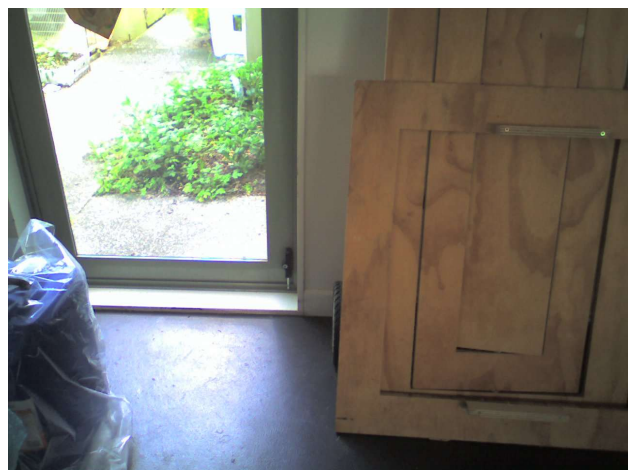
Garage - Moisture readings slightly above 40 digits detected in areas near floor to right hand side of doorway. No thermal variation detected in this area at time of inspection.

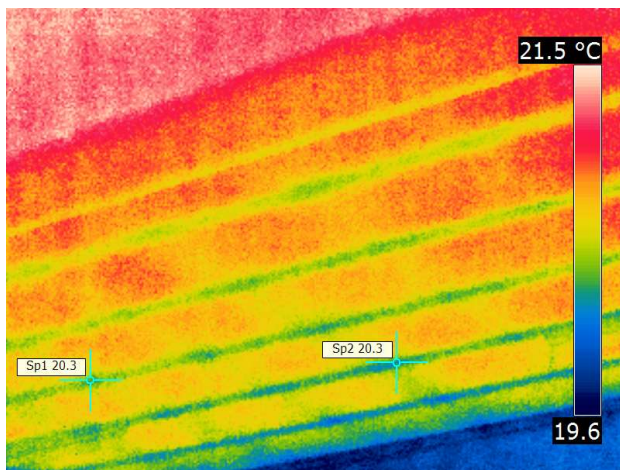
Garage - Thermal image displays even temperature distribution in areas of ceiling in garage. All moisture readings below 40 digits in this area at time of inspection.

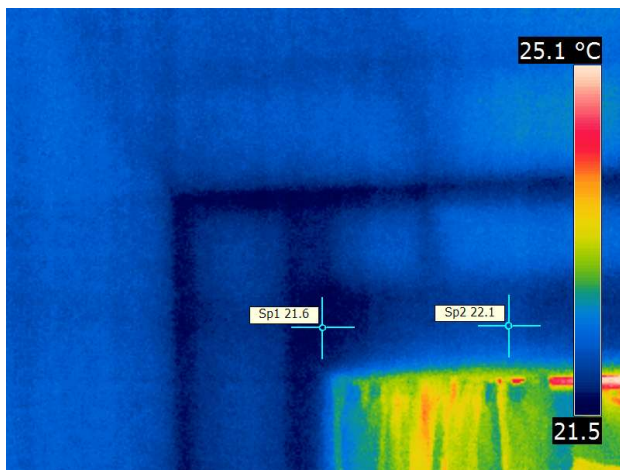
Stairway - Moisture readings slightly elevated on areas of window lintel consistent with other areas of the house.

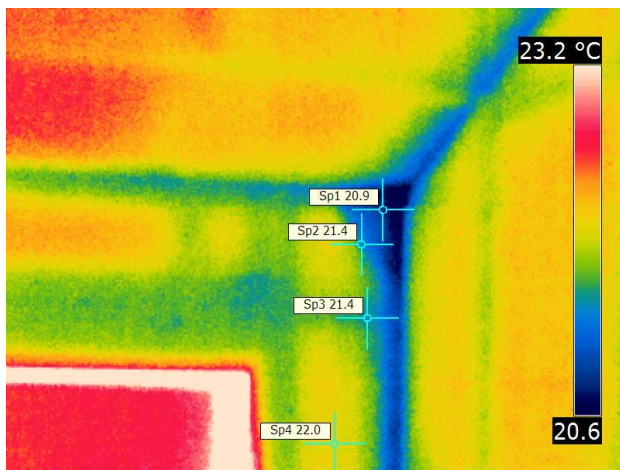
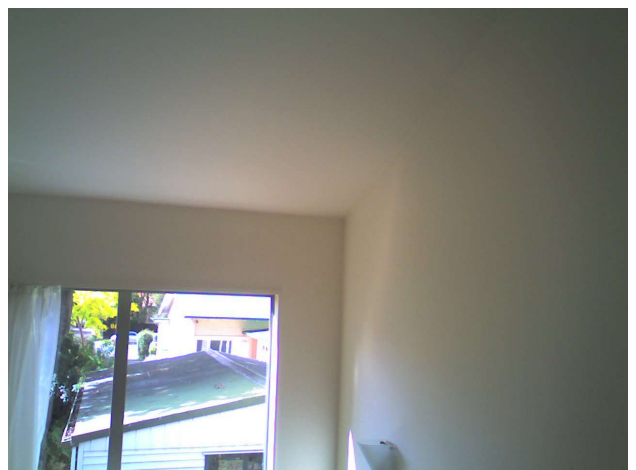
Stairway - Excessive moisture readings detected in areas of thermal variation in corner of ceiling. Further investigation recommended in this area.

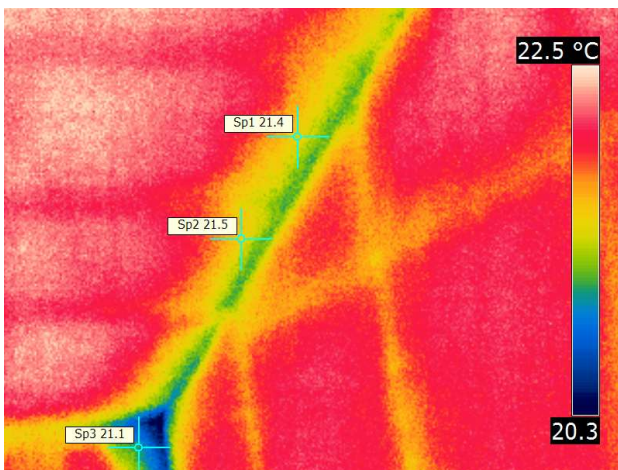
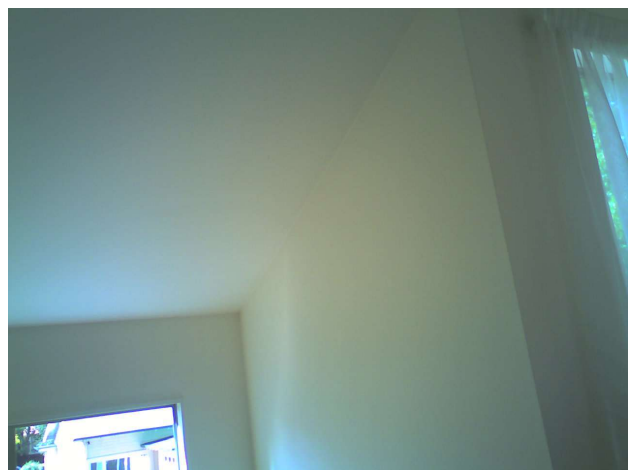
Stairway - Excessive moisture readings detected in areas of thermal variation in Sp3 near corner of ceiling. Moisture readings also high in areas of ceiling near Sp1 and Sp2. Further investigation recommended in this area.

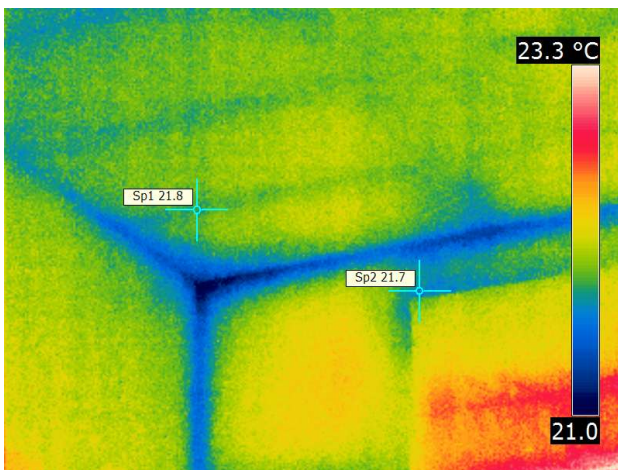
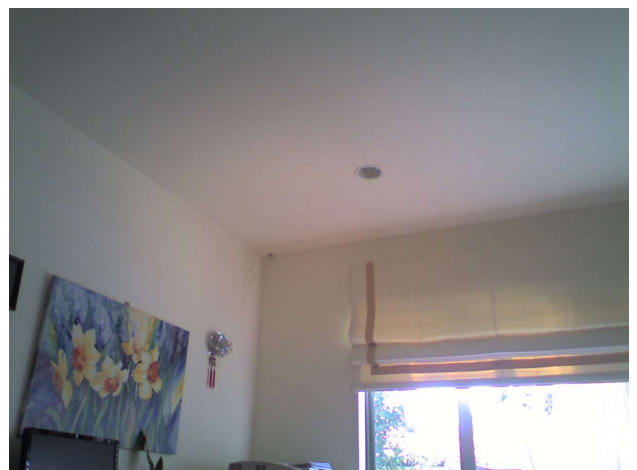
Living room (upstairs) - Slightly elevated moisture readings detected in areas above window lintel at time of inspection. Consistent with other rooms in the house. Internal walls and ceiling below 25 digits in this area.

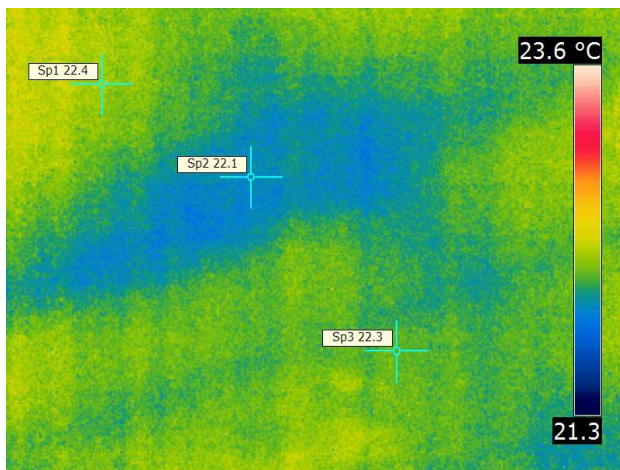
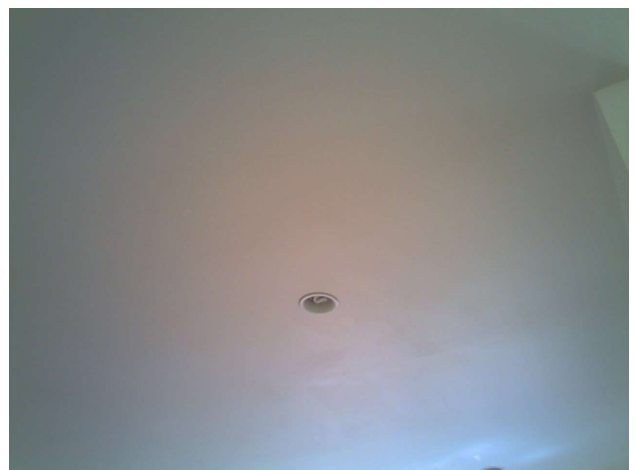
Living room (upstairs) - Areas of minor thermal variation detected in ceiling in this living room. No elevated moisture readings in this area at time of inspection.

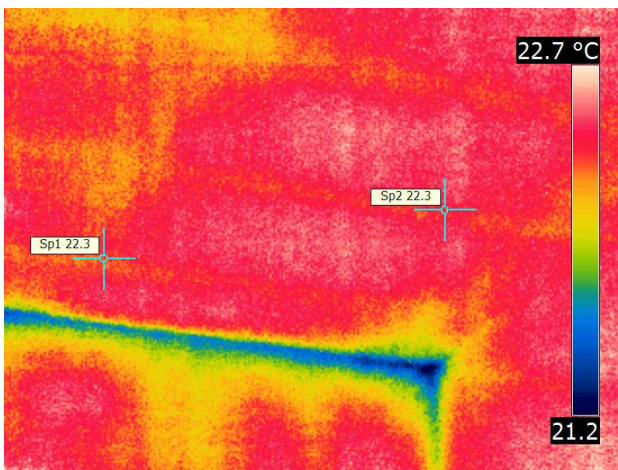
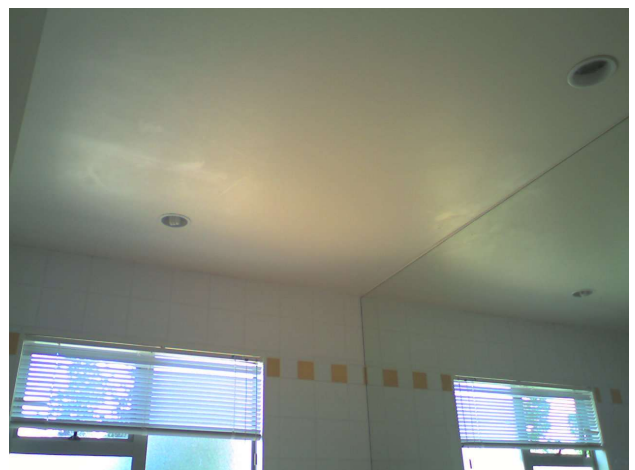
Bathroom (upstairs) - Walls in bathroom tiled from floor to ceiling, moisture readings unable to be taken from tiled areas. Areas of ceiling and window frames indicated low moisture readings below 40 digits at time of inspection.

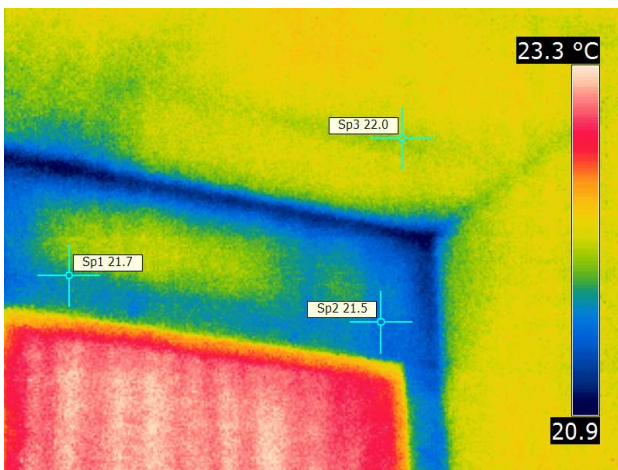
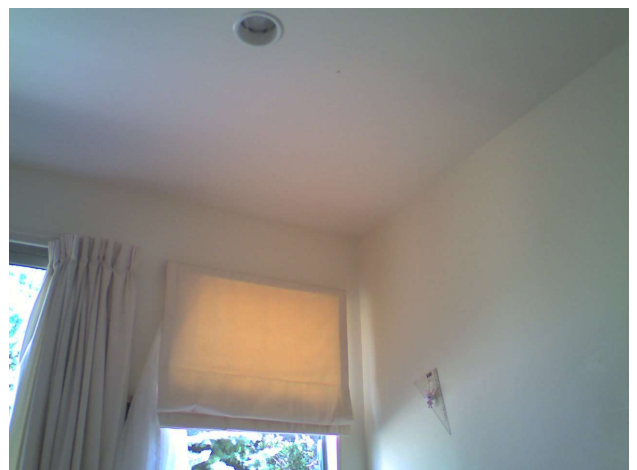
Bedroom 1 - No elevated moisture readings detected in this area. All moisture readings below 40 digits in this bedroom at time of inspection.

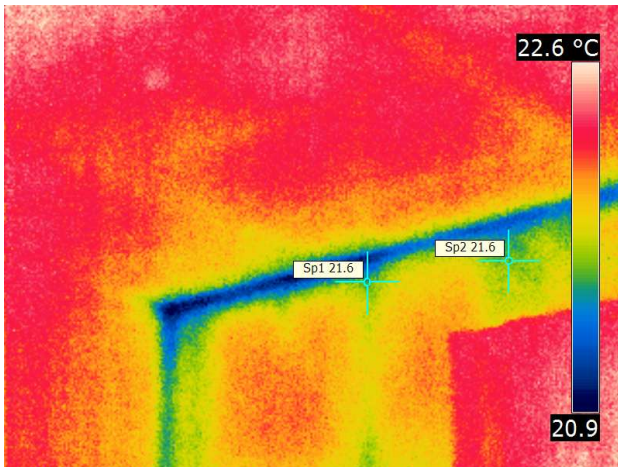
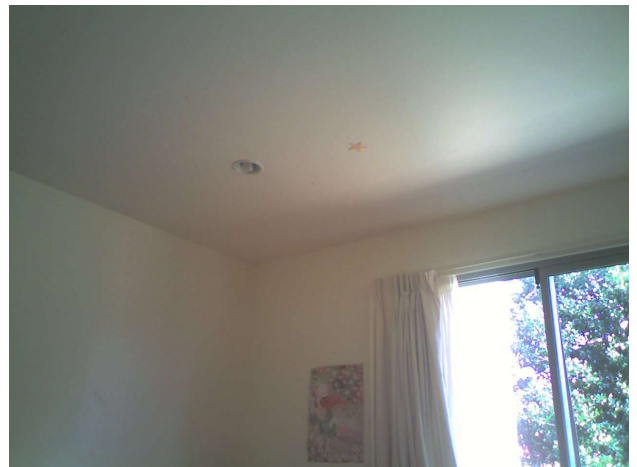
Bedroom 1 - Minor thermal variation detected in area near Sp2 above window lintel. Minor cracks from corner of window to ceiling in this room. All moisture readings taken below 40 digits at time of inspection.

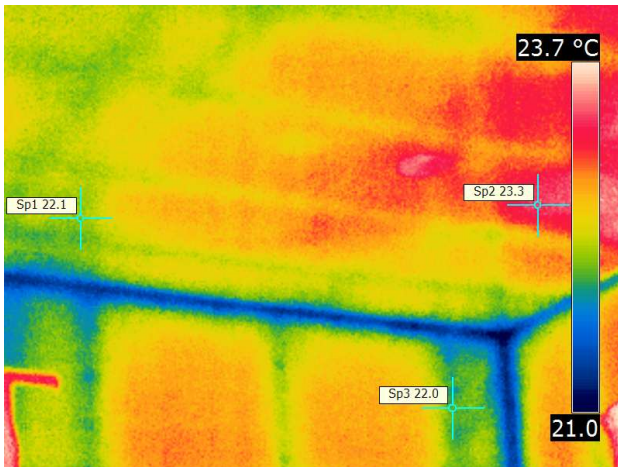
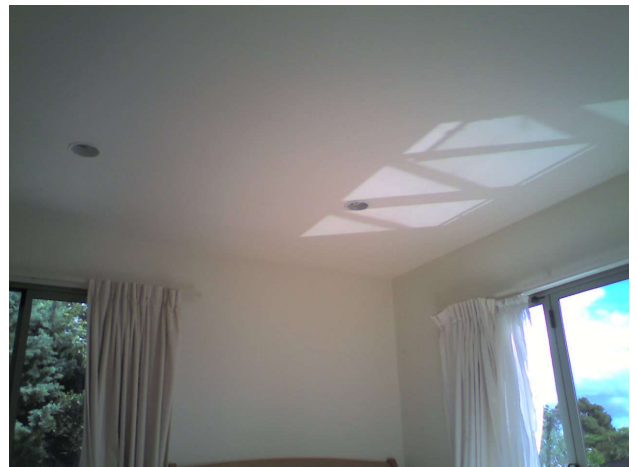
Bedroom 2 - Minor thermal variations detected in areas of ceiling may be due to missing insulation. Minor cracks from corner of window to ceiling in this room. All moisture readings taken in this room below 40 digits at time of inspection.

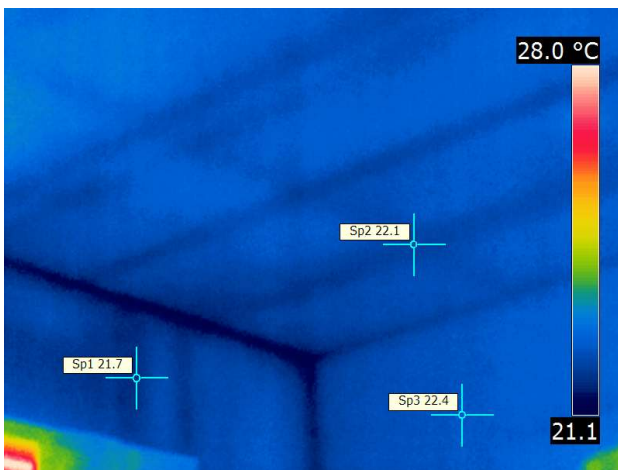
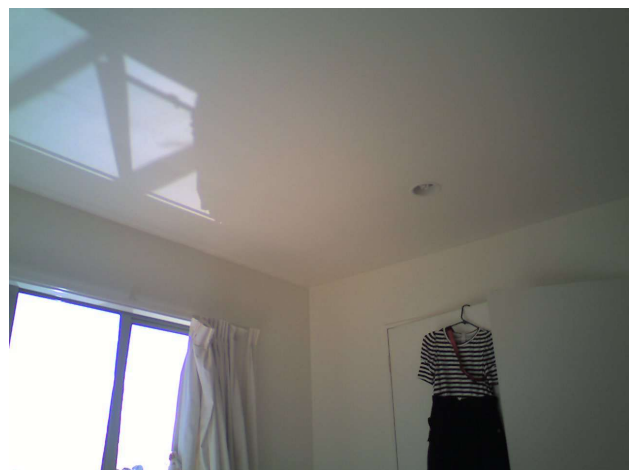
Bedroom 2 - Even temperature distribution shown in this area with no areas of thermal variations. All moisture readings below 40 digits in this area at time of inspection.

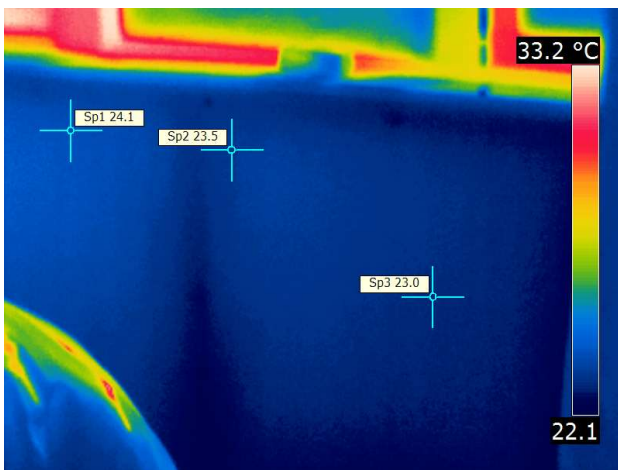
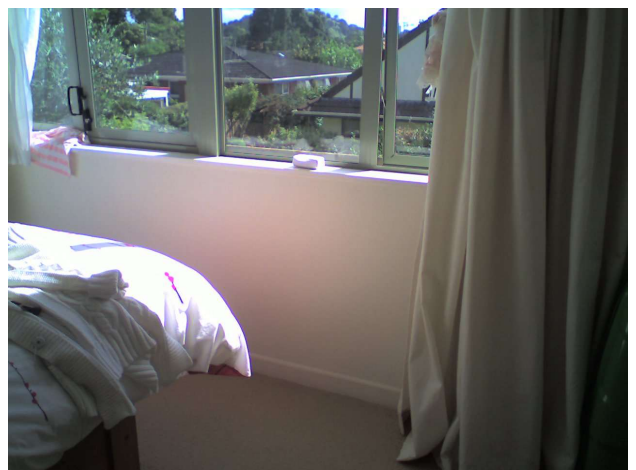
Bedroom 2 - Moisture readings slightly higher in areas below window frame in this bedroom. All moisture readings taken in this area below 40 digits at time of inspection. No thermal variation detected.

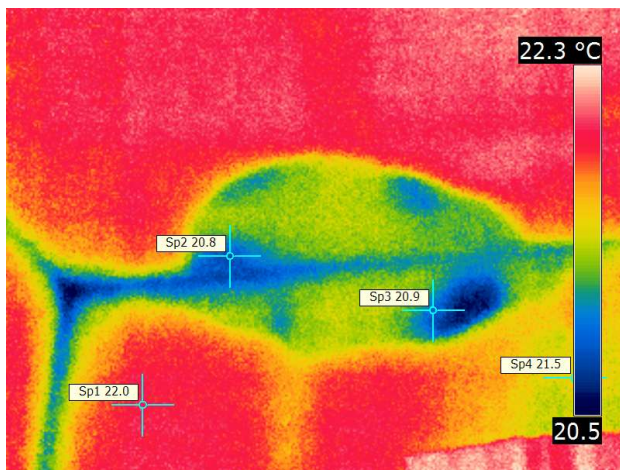
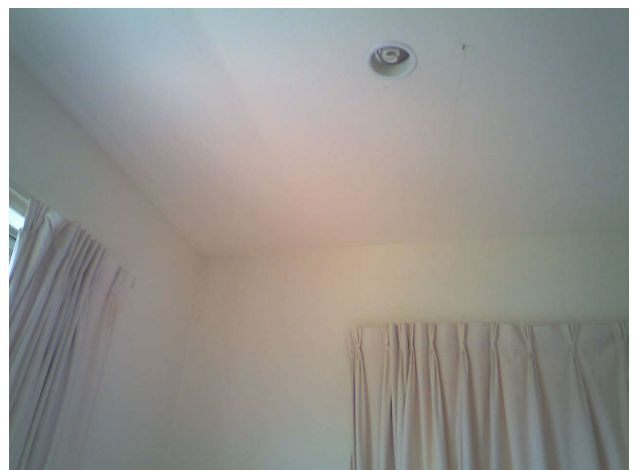
Bedroom 3 - Thermal variation detected in this bedroom near corner of ceiling and wall. Significantly higher moisture readings in thermal variation confirms moisture intrusion to bedroom. Further investigation is recommended in this area.

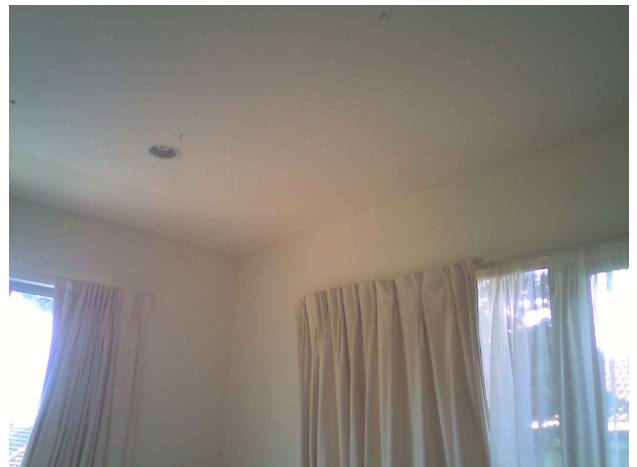
Bedroom 3 - Thermal variation detected in this bedroom near corner of ceiling and wall. Significantly higher moisture readings in thermal variation confirms moisture intrusion to bedroom. Further investigation is recommended in this area.

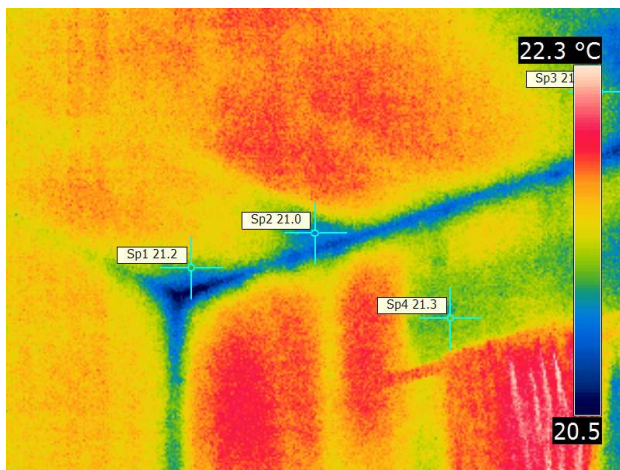
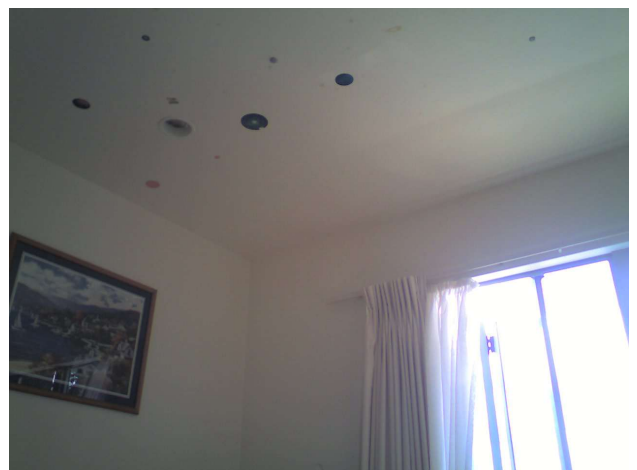
Bedroom 3 - Thermal variations detected in ceiling in this area. No elevated moisture readings detected in this area at time of inspection. Moisture readings on lintel consistent with other rooms.

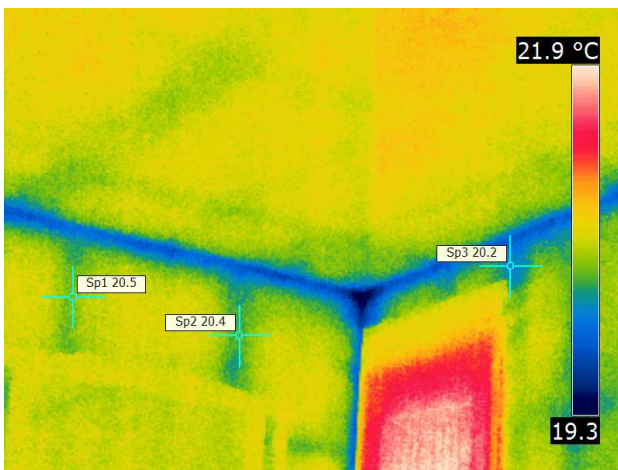
Master bedroom - Even temperature distribution shown in this area with no areas of thermal variation. All moisture readings below 40 digits in this area at time of inspection.

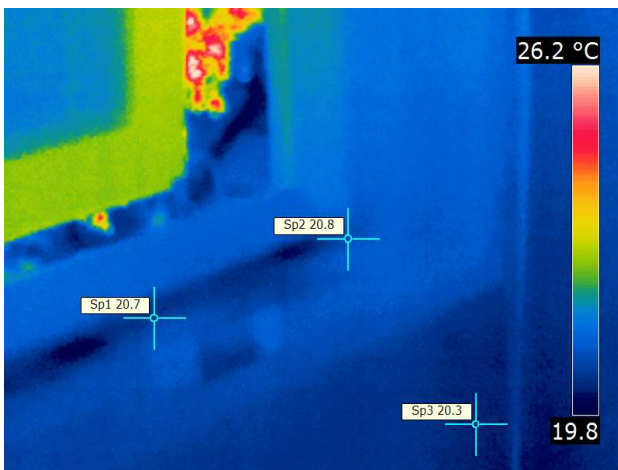
Master bedroom - Areas of previous water damage detected in corner of window frame. Mould located in this area. Moisture readings slightly above 40 digits in this area at time of inspection.
