Thermal Image Moisture Report

NZ Moisture Testing
PO Box 97528, S.A.M.C
P 0800 NZ Moisture
M 021 753 411
E info@nzmoisturetesting.co.nz
www.nzmoisturetesting.co.nz

Report Date 1/03/2011

House description - Four bedroom, two storey dwelling. Plaster construction with a tile roof and aluminium joinery. House inspected at 9am in clear sunny conditions. Contact person: xxx xxx

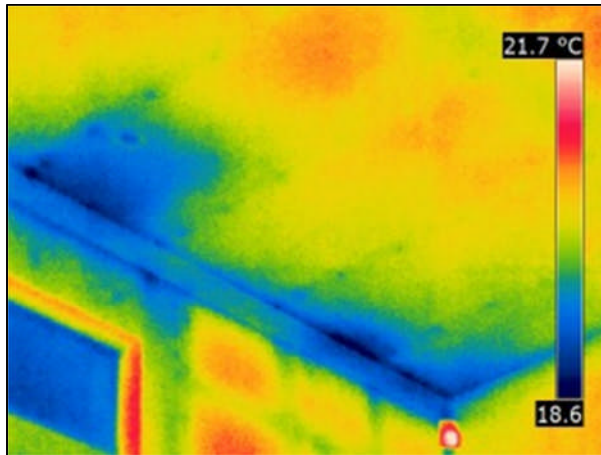
This image shows the corner of a room including part of the wall and ceiling, there is a difference and inconsistent distribution in temperature which would indicate the presence of a thermal anomaly.

When moisture readings were taken in this area, they were significantly higher in the colder "blue" areas (up to 120 digits).

This is an example of a serious problem of moisture intrusion and an area of concern. A recommendation for further investigation would be expressed in this instance normally a form of invasive testing will be required.

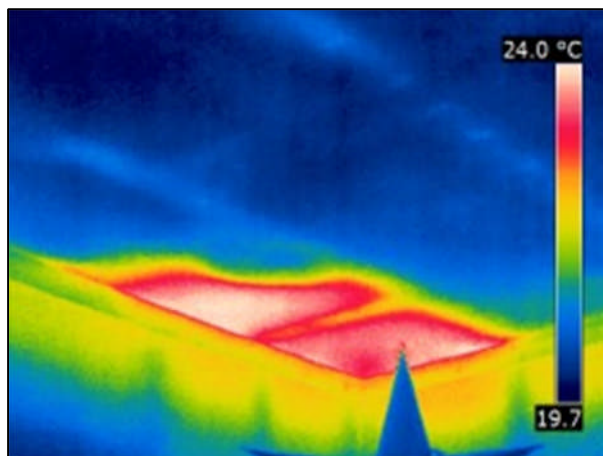
This image was taken at midday and is of a ceiling in a main living room in a home. There is a clear thermal variation with areas of the ceiling reading up to 24°C.

This thermal anomaly is an example of missing insulation in the ceiling. The areas with a higher temperature show where there is no insulation. This thermal image indicates that the air in the roof cavity was warmer than the ambient room temperature.

This thermal image will be reversed if taken at night when the roof cavity temperature will be lower than the rooms.

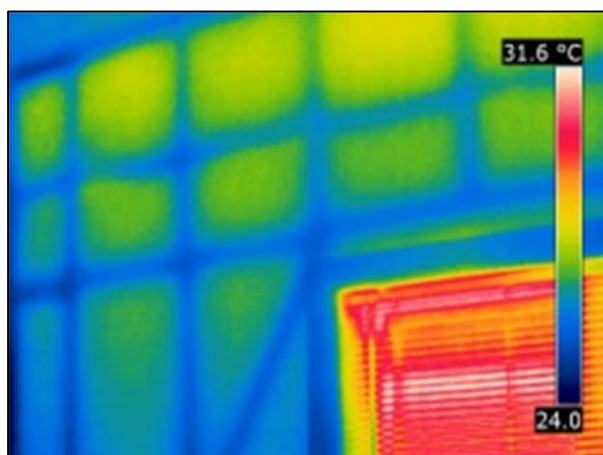
This image shows the IR cameras ability to show the internal framework of a building.

We can see the temperature is consistent and even throughout the wall.

This is considered a normal and even temperature distribution and would indicate that there are no thermal anomalies. Once moisture readings have been taken in this area will confirm there are no moisture issues present.

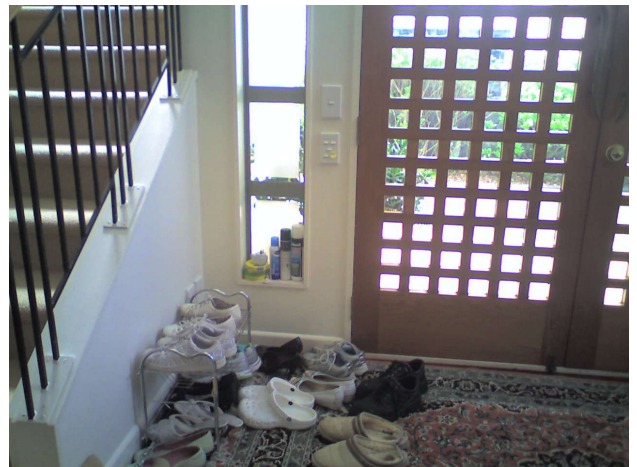
Camera Model	FLIR T360_ Western
Image Date	23/03/2011 8:46:50 a.m.
Image Name	IR 3390 Entryway.jpg
Emissivity	0.95
Reflected apparent temperature	20.0 °C
Object Distance	1.0 m

Entryway - Low moisture readings taken around doorway near floor. All moisture readings below 40 digits at time of inspection.

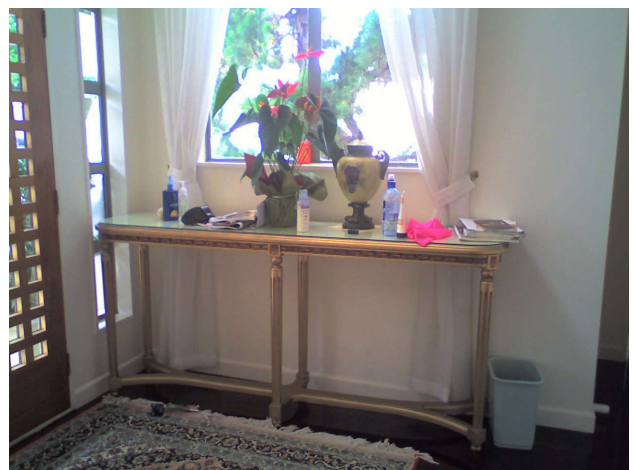
Camera Model FLIR T360_ Western
 Image Date 23/03/2011 8:47:13 a.m.
 Image Name IR 3392 Entryway.jpg
 Emissivity 0.95
 Reflected apparent temperature 20.0 °C
 Object Distance 1.0 m

Entryway - Low moisture readings below 40 digits detected in this area below window. Small cracks noted in wall in this area and also areas above doorway.

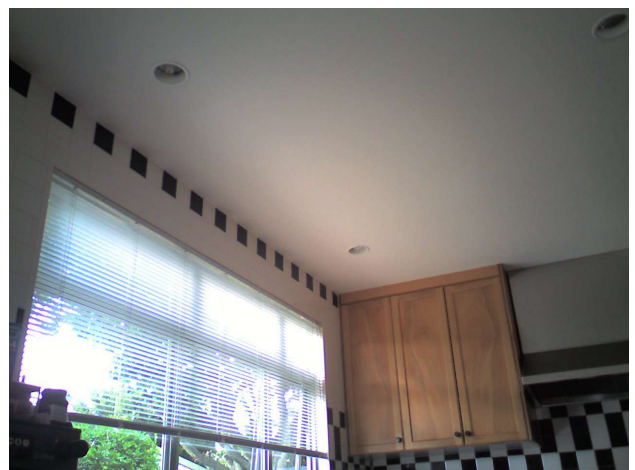
Camera Model	FLIR T360_ Western	Sp1	7 digits
Image Date	23/03/2011 8:52:00 a.m.	Sp2	15 digits
Image Name	IR 3394 Kitchen.jpg	Sp3	11 digits
Emissivity	0.95		
Reflected apparent temperature	20.0 °C		
Object Distance	1.0 m

Kitchen - Walls in kitchen tiled to ceiling, moisture readings unable to be taken from tiled areas. Areas of thermal variation in ceiling may be due to missing or damaged insulation. Moisture readings below 40 digits in this area at time of inspection.

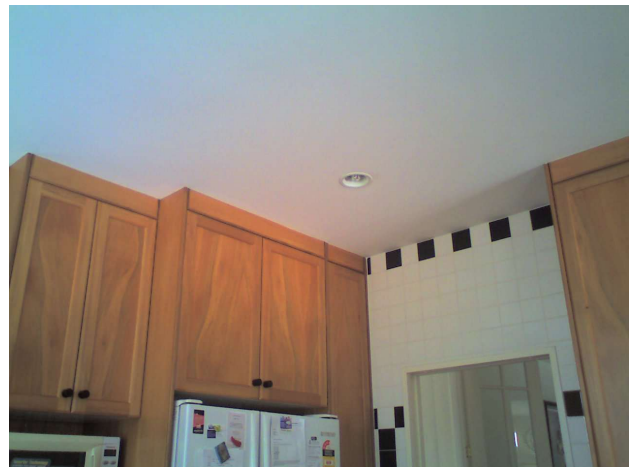
Camera Model	FLIR T360_ Western	Sp1	8 digits
Image Date	23/03/2011 8:53:11 a.m.	Sp2	17 digits
Image Name	IR 3400 Kitchen.jpg	Sp3	15 digits
Emissivity	0.95		
Reflected apparent temperature	20.0 °C		
Object Distance	1.0 m

Kitchen - Areas of minor thermal variation in ceiling may be due to missing or damaged insulation. All moisture readings below 40 digits in this area of kitchen at time of inspection.

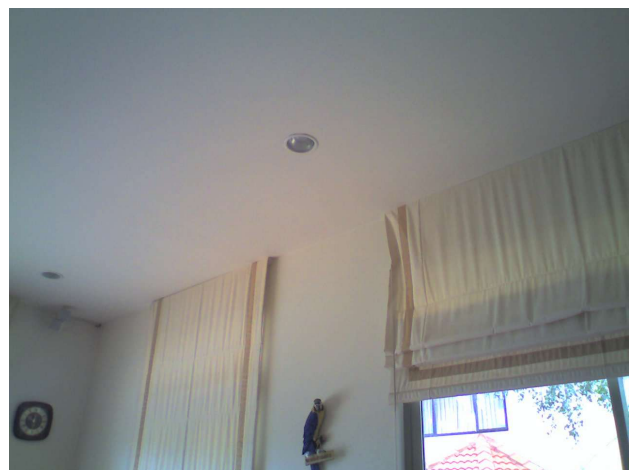
Camera Model	FLIR T360_ Western	Sp1	7 digits
Image Date	23/03/2011 8:57:29 a.m.	Sp2	15 digits
Image Name	IR 3402 Living room 1.jpg	Sp3	14 digits
Emissivity	0.95		
Reflected apparent temperature	20.0 °C		
Object Distance	1.0 m

Living room 1 - Minor thermal variation detected in areas of ceiling in this living room. No elevated moisture readings were detected in this area at time of inspection. All moisture readings below 40 digits in this area.

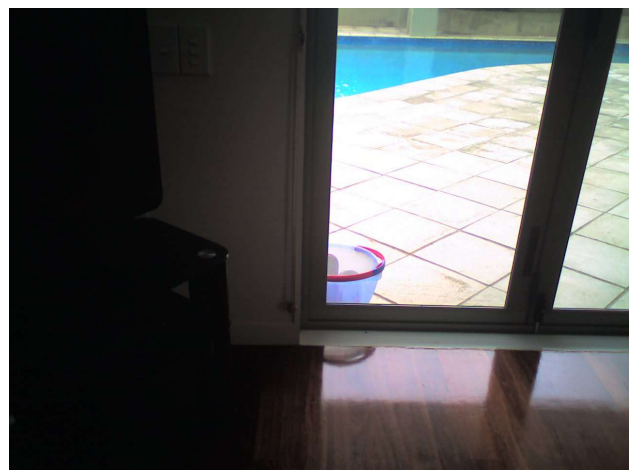
Camera Model	FLIR T360_ Western	Sp1	37 digits
Image Date	23/03/2011 8:59:29 a.m.	Sp2	45 digits
Image Name	IR 3410 Living room 1.jpg	Sp3	57 digits
Emissivity	0.95		
Reflected apparent temperature	20.0 °C		
Object Distance	1.0 m

Living room 1 - Moisture readings above 40 digits detected in areas near floor to side of doorway. No thermal variation detected in this area at time of inspection.

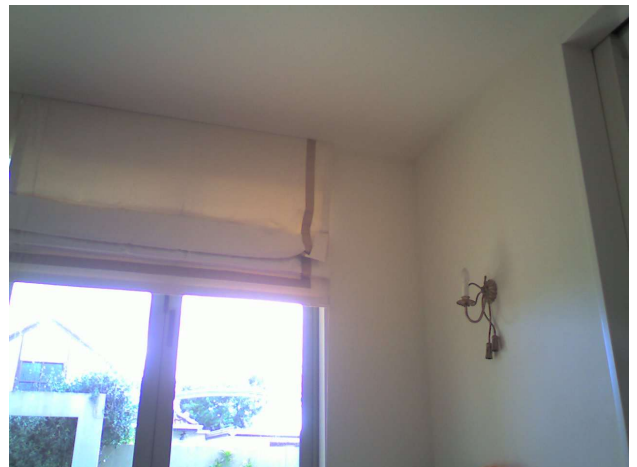
Camera Model	FLIR T360_ Western	Sp1	43 digits
Image Date	23/03/2011 9:18:40 a.m.	Sp2	23 digits
Image Name	IR 3430 Dining room.jpg		
Emissivity	0.95		
Reflected apparent temperature	20.0 °C		
Object Distance	1.0 m

Dining room - Small cracks noted in wall from top corners of window frames to ceiling above most windows. Moisture readings above 40 digits in these areas on lintels consistent throughout house. No thermal variance detected in this area.

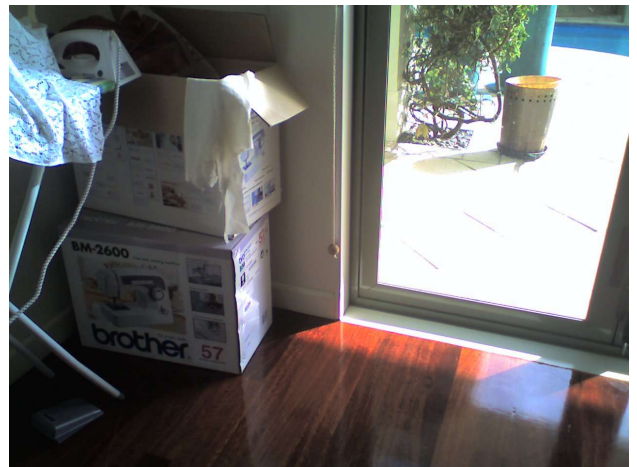
Camera Model	FLIR T360_ Western	Sp1	25 digits
Image Date	23/03/2011 9:23:48 a.m.	Sp2	46 digits
Image Name	IR 3432 Dining room.jpg	Sp3	52 digits
Emissivity	0.95		
Reflected apparent temperature	20.0 °C		
Object Distance	1.0 m

Dining room - Moisture readings above 40 digits detected in areas near floor to side of doorway. No thermal variation detected in this area at time of inspection.

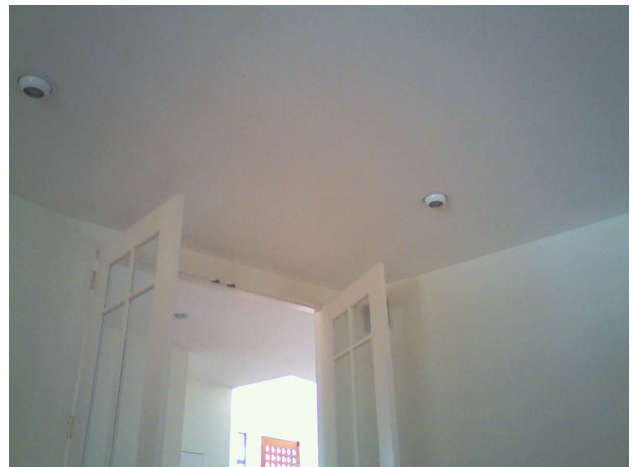
Camera Model	FLIR T360_ Western	Sp1	17 digits
Image Date	23/03/2011 9:06:30 a.m.	Sp2	18 digits
Image Name	IR 3412 Living room 2.jpg		
Emissivity	0.95		
Reflected apparent temperature	20.0 °C		
Object Distance	1.0 m

Living room 2 - Areas of minor thermal variation in ceiling may be due to missing or damaged insulation. All moisture readings below 40 digits in this area of living room at time of inspection.

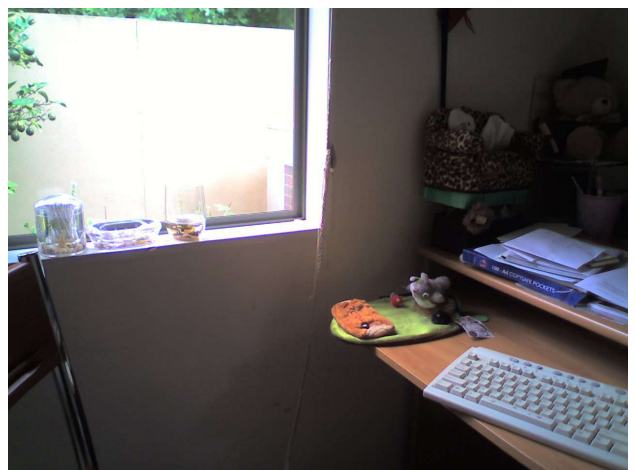
Camera Model	FLIR T360_ Western	Sp1	34 digits
Image Date	23/03/2011 9:33:57 a.m.	Sp2	28 digits
Image Name	IR 3450 Office.jpg		
Emissivity	0.95		
Reflected apparent temperature	20.0 °C		
Object Distance	1.0 m

Office - Moisture readings above 40 digits detected below right hand corner of this window in office. Minor crack located in this area. Moisture readings below 40 digits in this area at time of inspection.

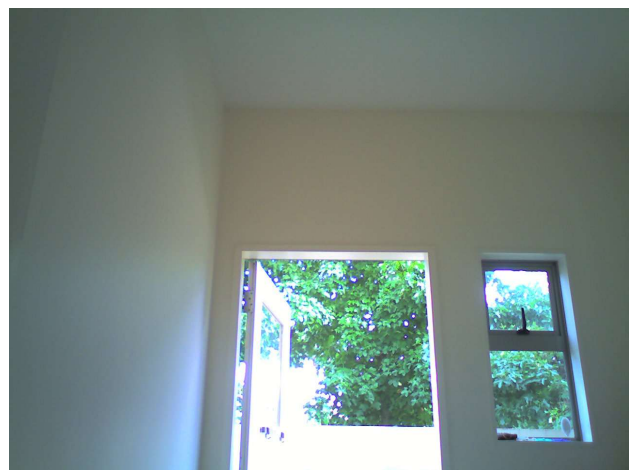
Camera Model	FLIR T360_ Western	Sp1	36 digits
Image Date	23/03/2011 9:39:22 a.m.	Sp2	33 digits
Image Name	IR 3456 Laundry.jpg		
Emissivity	0.95		
Reflected apparent temperature	20.0 °C		
Object Distance	1.0 m

Laundry - Highest moisture readings in this laundry attained from areas of wall above this doorway. All moisture readings in this area below 40 digits at time of inspection. No thermal variation present in this area.

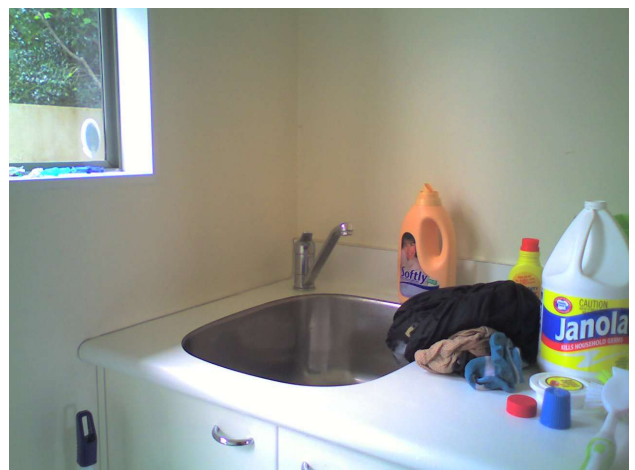
Camera Model	FLIR T360_ Western
Image Date	23/03/2011 9:40:49 a.m.
Image Name	IR 3462 Laundry.jpg
Emissivity	0.95
Reflected apparent temperature	20.0 °C
Object Distance	1.0 m

Laundry - Moisture readings on wall around sink area below 40 digits. Laundry in use at time of inspection.

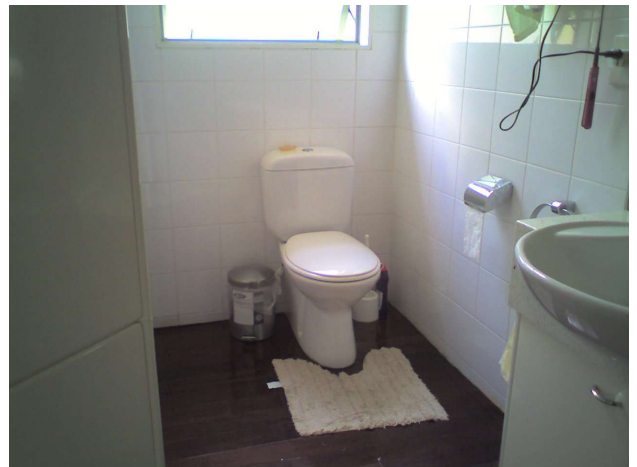
Camera Model	FLIR T360_ Western
Image Date	23/03/2011 9:44:52 a.m.
Image Name	IR 3468 Bathroom (downstairs).jpg
Emissivity	0.95
Reflected apparent temperature	20.0 °C
Object Distance	1.0 m

Bathroom (downstairs) - Walls in bathroom tiled from floor to ceiling, moisture readings unable to be taken from tiled areas. Areas of ceiling and window frames indicated low moisture readings below 40 digits at time of inspection.

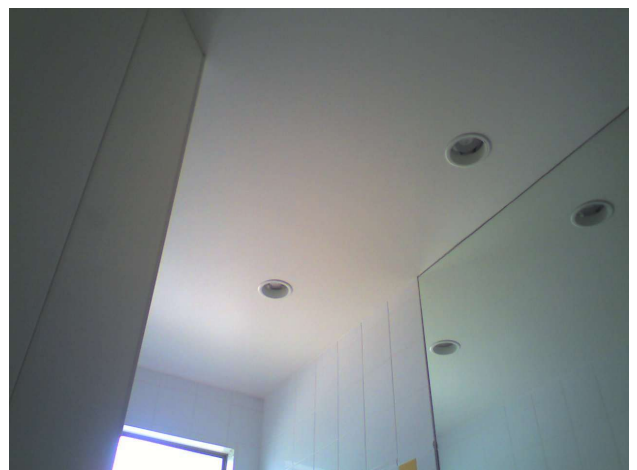
Camera Model	FLIR T360_ Western	Sp1	13 digits
Image Date	23/03/2011 9:45:17 a.m.	Sp2	9 digits
Image Name	IR 3470 Bathroom (downstairs).jpg	Sp3	11 digits
Emissivity	0.95		
Reflected apparent temperature	20.0 °C		
Object Distance	1.0 m

Bathroom - All moisture reading taken in this area below 40 digits at time of inspection. Thermal variances in areas of ceiling may be due to missing insulation. No elevated moisture readings in this bathroom.
